Silver Lake Park Restoration Updated Plan

Silver Lake Estates Board Meeting

September 12, 2016: 7 PM

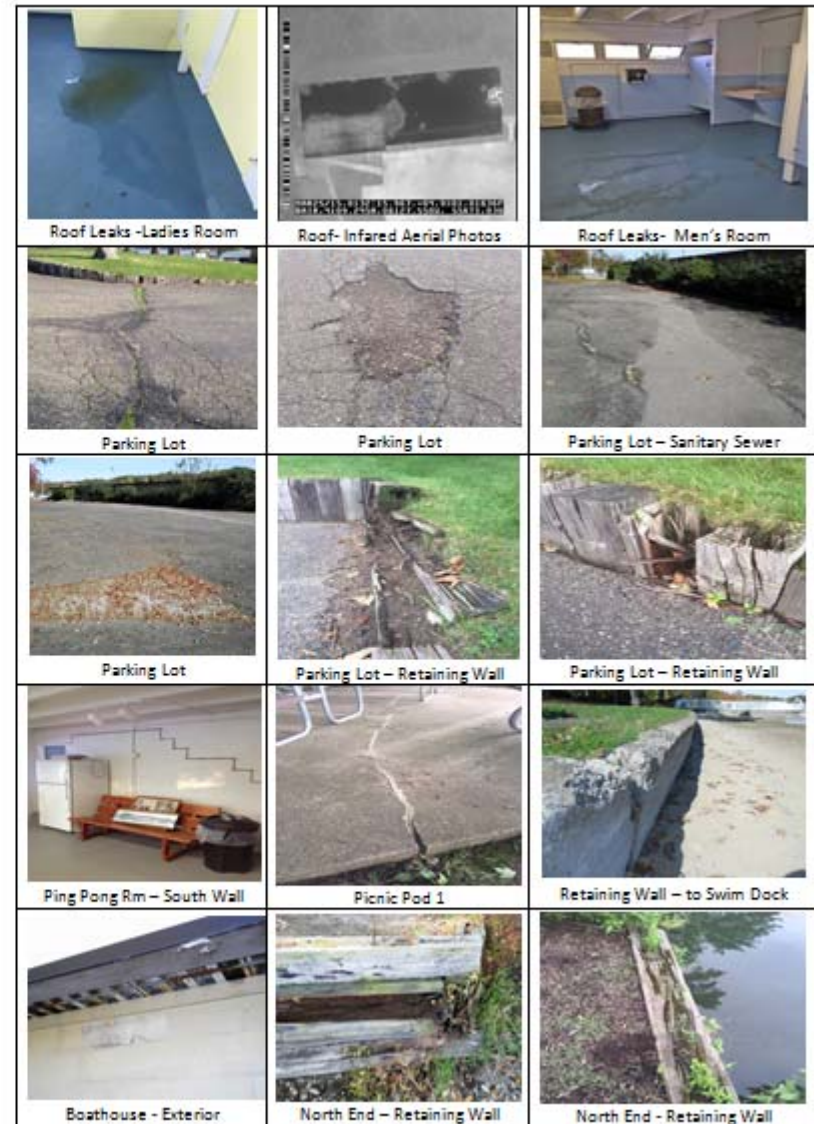
MAINTENANCE, REPAIR AND REPLACEMENTS

Several maintenance issues were identified by SLE's lot owner based Facilities Planning Committee 2004 though 2010 and corrections were planned for 2010-2011 as noted in the 2004 -2010 Newsletters and other letters to the lot owners. Property conditions in 2015 are the same or in most cases are worse.

- **Boathouse roof** - leaking due to age
- **Boathouse chimney** - adding to roof leak and structural issue (above the roof line)
- **Boathouse walls and floors** in poor condition due to use of only 32" deep footer, location next to a lake and storm water run off from parking lot and from the park.

- **Boathouse sanitary sewer line** - too shallow, subject to blockage and breakage
- **Parking lot** - blacktop not properly installed 50 yrs ago, damaged, incorrect grading

- **Parking lot curbs and retaining walls**- constructed with used RR ties 40+ years ago
- **Retaining wall** boathouse to swimming dock - 90+ yrs old and failing

- **Park north end retaining wall** - constructed with used RR ties, age and insect damage
- **Picnic pods** - concrete slabs (some of the picnic pod retaining walls have been replaced)

- **Need replacement trees** for those removed after lightning or insect damage
- **Children's playground** - needs additional repairs and replacement equipment

- **Government regulations and Codes** (village, county, region and Federal) impact maintenance, repairs and replacements choices.
- **Other safety issues** need to be addressed in the park property

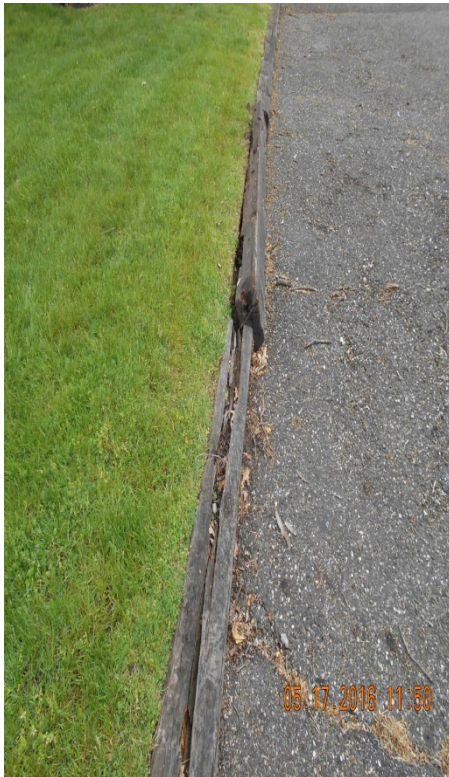
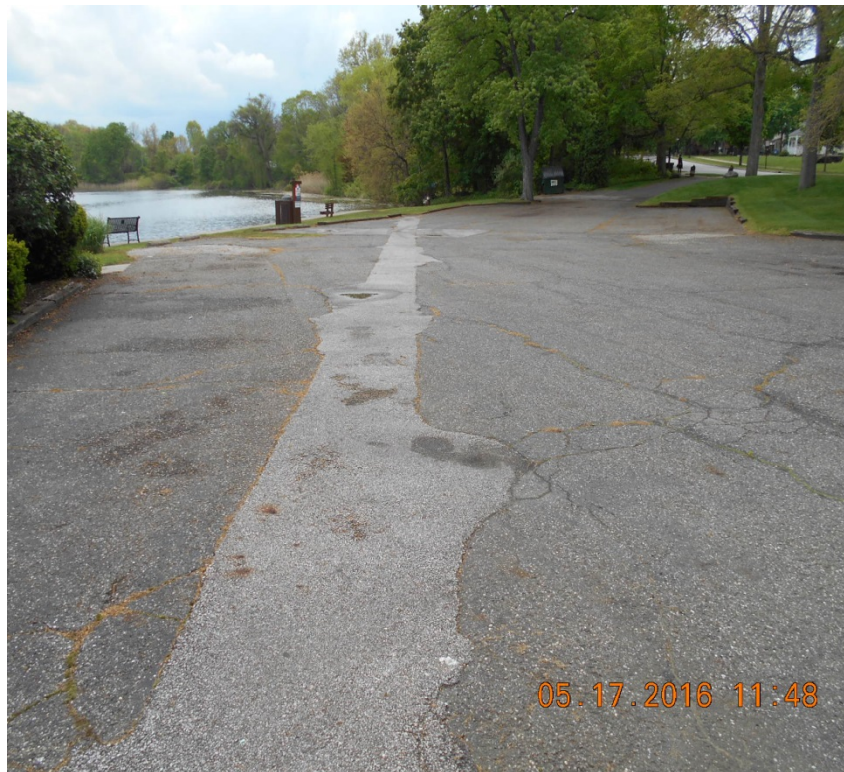
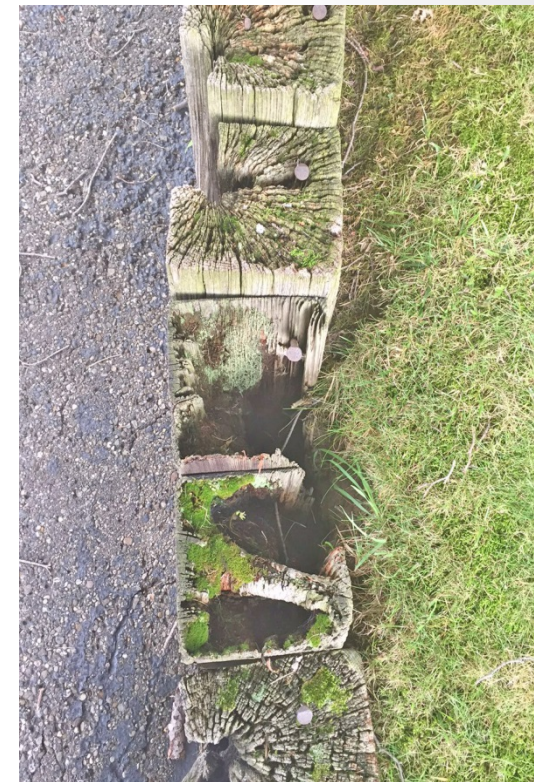
- Existing parking lot is **over 50 years old** and was not installed with a underlying blacktop base coat or intermediate coat (only top coat was installed)

Parking Lot - *Repairs*

- Remove all **timber curbs** on the West side of the parking lot and re-grade.
- Remove all **timber walls** on the North side of the parking lot and replace with 8 inch concrete extended curbs of approximately 18 inches on average in height.
- Remove all **timber curbs** on the East side of the parking lot and replace with 6 inch standard curbs.
- Provide and install a **storm water inlet** over the existing 36 inch storm sewer pipe and center on the parking lot.
- *Provide full depth pavement replacement over top of the existing storm sewer and repair the gaps in the storm sewer pipe. This work to be completed by the Village of Silver Lake.*
- Grind pavements at all drive and sidewalk transitions.

- Provide **asphalt topping** varying in thickness from 1-1/4 inch minimum to a 3 inch maximum to provide positive flow to the new catch basin.
- **Repair erosion** behind the existing retaining wall, re-grade and restore.
- Revise the **sanitary sewer casting** to accommodate the new grades as required.
- Provide a 5 foot wide **sidewalk** to accommodate the child access to the fishing dock.
- Provide an 8 inch concrete pad for the trash **dumpster**.
- Replace the **bike storage** area with a new concrete slab.
- Remove any **vegetation** necessary to accommodate the new sidewalk.
- **Stripe** the parking lot with a revised parking space layout.
- **Restore** all surrounding areas.

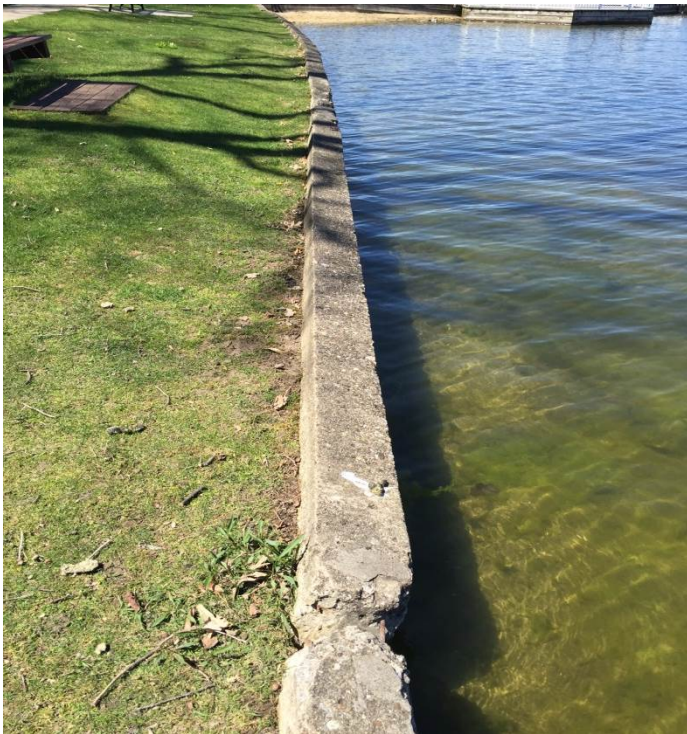
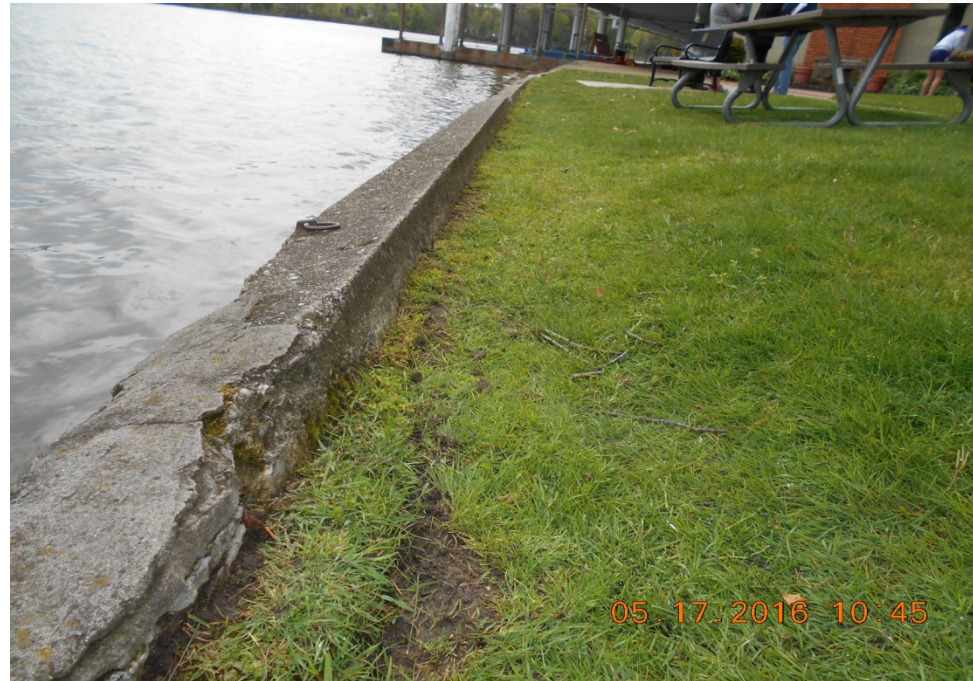
Boathouse /Swim Dock Retaining Wall

- Severe spalling, unsafe exposed rebar, leaning and washout

Boathouse / Swim Dock Retaining Wall Replacement

- Remove existing concrete lakeside retaining wall.
- Install new concrete retaining wall to the new layout (including space for a new Pod # 10.) < flat space for senior citizens and ADA >
- Provide premium backfill for the ADA Pod # 10.
- Restore the area.

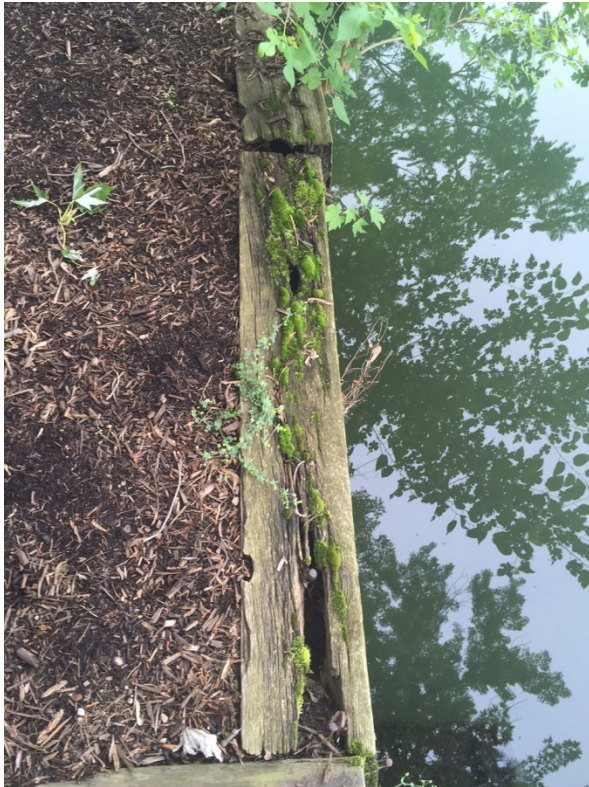
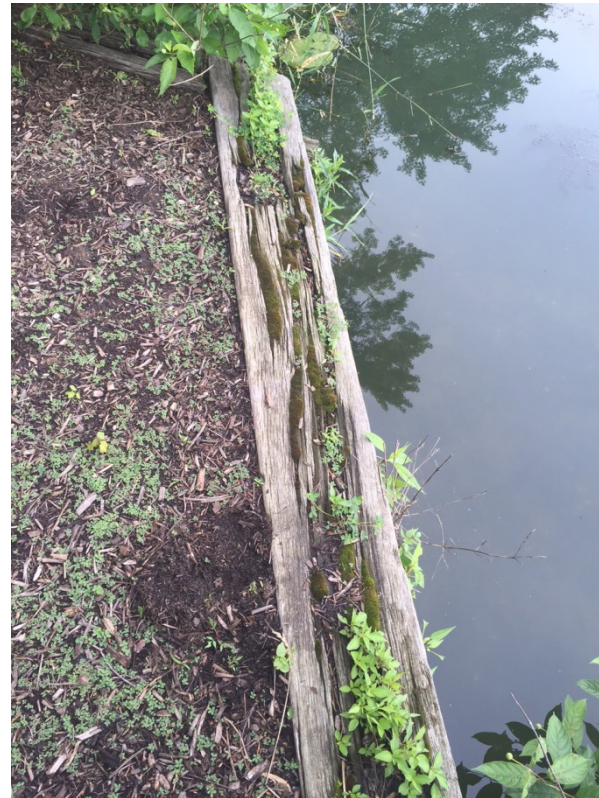
- Severe rotting **timbers**, erosion and washout

North Lakeside Retaining Wall *Replacement*

- Remove the existing **timber** retaining walls and replace with new tiered retaining concrete modular walls.
- Provide all necessary premium backfill as required.
- Restore the area.

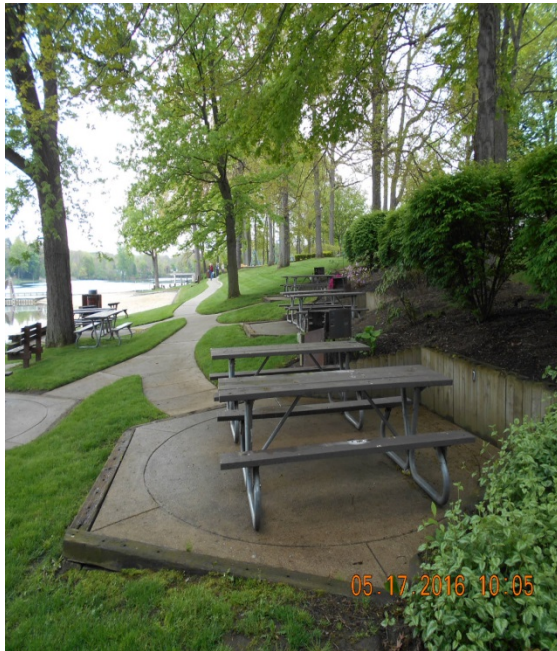
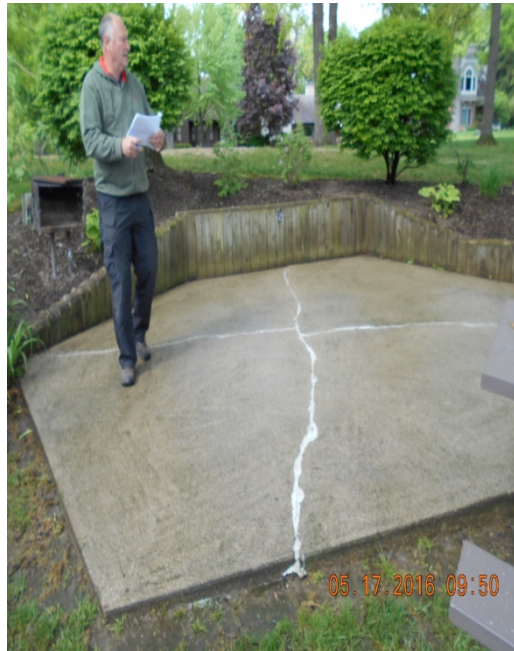
- Rotting vertical and in-ground **timbers**, severe cracks in pads
- Replacement of north seawall will require adjacent concrete pad replacement (#8 and #9)
- Remove in-ground **timbers** adjacent to north end pads

Picnic Pods - *Repairs*

- Remove all existing **timber walls** and curbs on Pod Nos. 3 thru 7 and replace with new retaining concrete modular walls.
- Remove all existing **timber walls** and concrete slabs on Pod # 1, 2, 8, & 9 and replace with new retaining concrete modular walls, and concrete slabs as required. Pod # 1 and # 2 are to be ADA accessible areas.
- Install ADA Pod # 10
- Provide 5 foot wide concrete sidewalks to accommodate the ADA accessible areas at Pod # 1 and # 2
- Restore all areas.

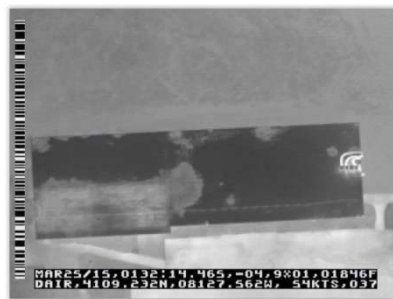
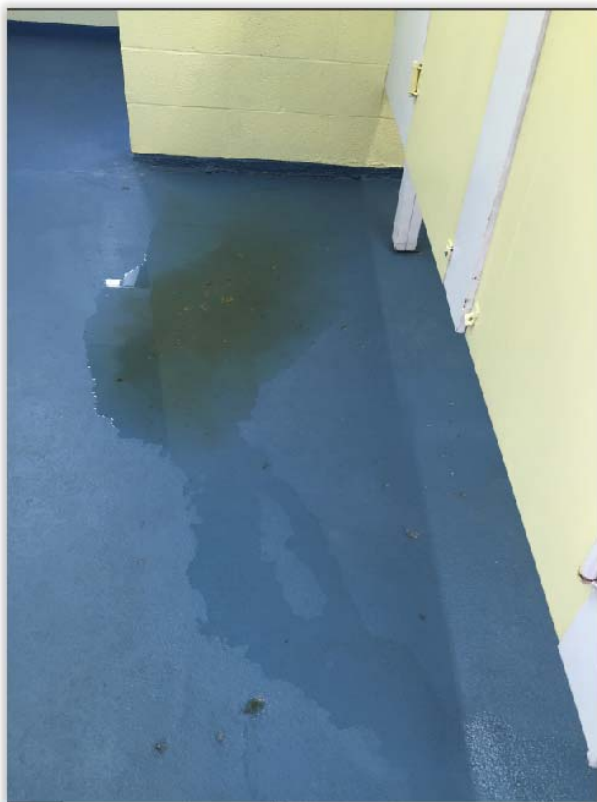
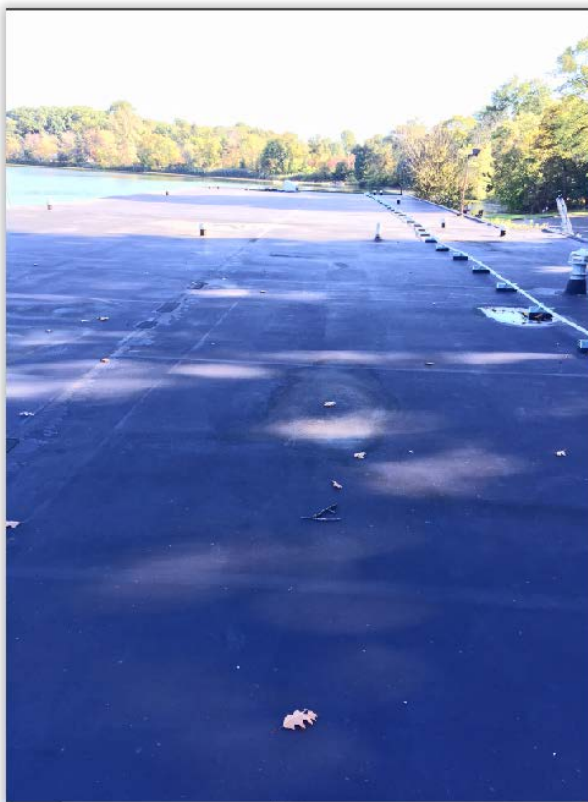
ROOF AND FASCIA . . . WERE REPLACED

Spring 2016 (via 2016 budget)
