# Silver Lake Park Restoration

Town Hall for  
Silver Lake Estates Lot Owners

August 17, 2016: 3 PM and 7 PM

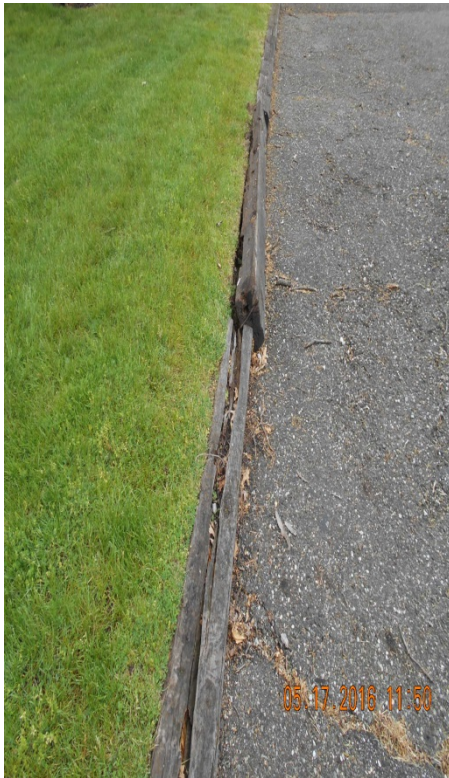
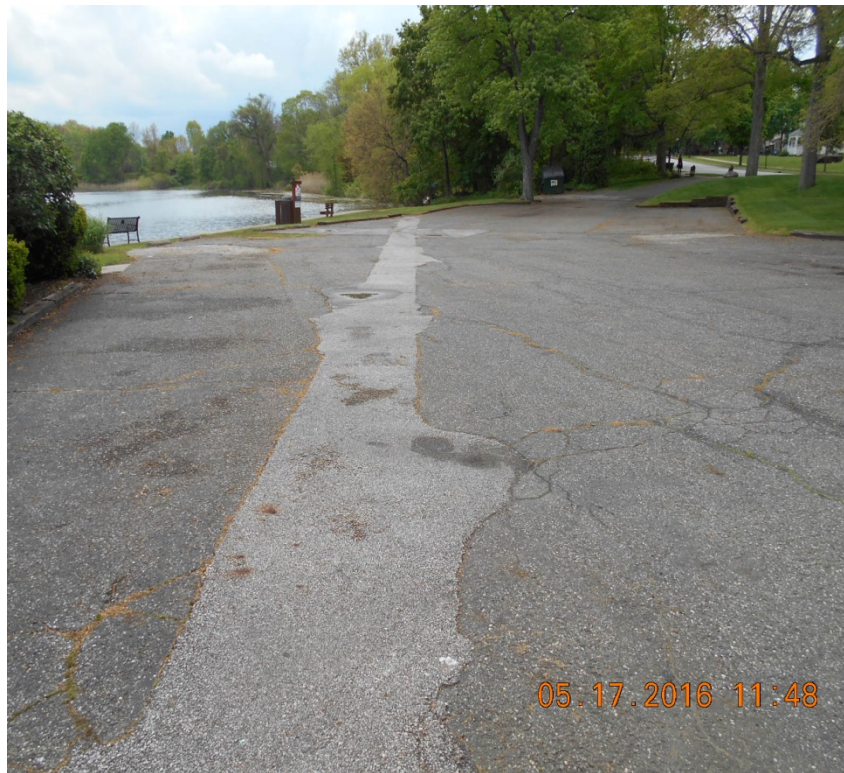
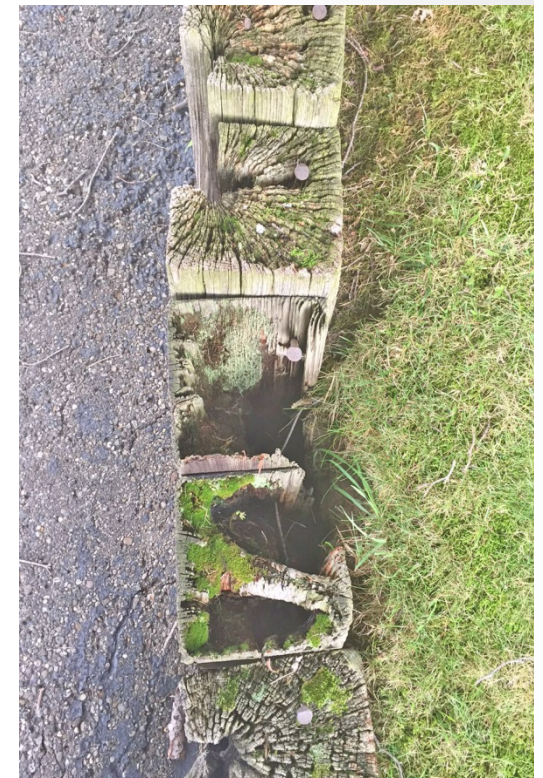
- Existing parking lot is ***over 50 years old*** and was not installed with a underlying blacktop base coat or intermediate coat (only top coat was installed)

# Parking Lot - *Repairs*

- Remove all **timber curbs** on the West side of the parking lot and re-grade.
- Remove all **timber walls** on the North side of the parking lot and replace with 8 inch concrete extended curbs of approximately 18 inches on average in height.
- Remove all **timber curbs** on the East side of the parking lot and replace with 6 inch standard curbs.
- Provide and install a **storm water inlet** over the existing 36 inch storm sewer pipe and center on the parking lot.
- *Provide full depth pavement replacement over top of the existing storm sewer and repair the gaps in the storm sewer pipe. This work to be completed by the Village of Silver Lake.*
- Grind pavements at all drive and sidewalk transitions.

- Provide **asphalt topping** varying in thickness from 1-1/4 inch minimum to a 3 inch maximum to provide positive flow to the new catch basin.
- **Repair erosion** behind the existing retaining wall, re-grade and restore.
- Revise the **sanitary sewer casting** to accommodate the new grades as required.
- Provide a 5 foot wide **sidewalk** to accommodate the child access to the fishing dock.
- Provide an 8 inch concrete pad for the trash **dumpster**.
- Replace the **bike storage** area with a new concrete slab.
- Remove any **vegetation** necessary to accommodate the new sidewalk.
- **Stripe** the parking lot with a revised parking space layout.
- **Restore** all surrounding areas.
